FAA-AM-81-10

IMPROVING THE CRASHWORTHINESS OF GENERAL
AVIATION AIRCRAFT BY CRASH INJURY INVESTIGATIONS

William R. Kirkham, M.D., Ph.D.
Civil Aeromedical Institute
Federal Aviation Administration
Oklahoma City, Oklahoma

MAY 1981

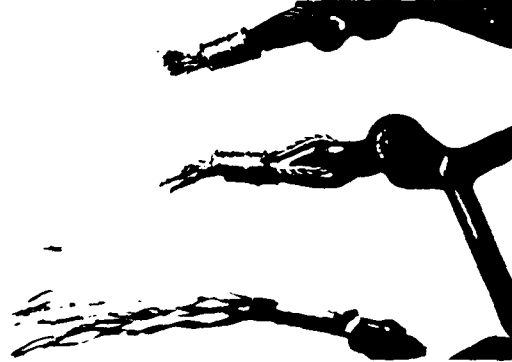
The pilot of an aerial application aircraft inadvertently dipped his right wing in some wheat and, on recovering, struck a parked cotton trailer with the left wing tip. The aircraft hit the ground and came to rest inverted. The cockpit remained intact (Figure VIa) but the seatbelt attachment cables and the shoulder harness cable failed (Figure VIb), allowing the pilot to come forward. His head struck the metallic wirecutter in front of the windscreen and his chest made a broad impact on the panel. The pilot's helmet sustained a large vertical cleavage corresponding to the impact with the wirecutter and the pilot suffered a corresponding laceration of the forehead.

The crash injury investigator could not understand why all three cables would fail in such an accident. He began to look at other aircraft in service and study the cables. In this aircraft the cable to the shoulder harness coursed over a pulley and down behind the pilot to an inertia reel. The lap-belt attached to cables that passed through an opening in a bulkhead (around

Figure VI. Pilot of aircraft (a) received head and chest injuries as, on impact, he came forward into windscreen, wirecutter, and instrument panel. Cables used on shoulder harness and lapbelts all failed (b). Stronger cables and modified routing apparently rectified the condition.

the pilot) and the cables were fixed to the frame of the aircraft. In both places, over the pulley and where cables pass through the bulkhead, they were subjected to wear and considerable recurrent acute bending. In some operational aircraft, filaments of the multistrand cable were found to be broken. This configuration of the cable attachments for the shoulder harness and lapbelts appeared to subject them to wear and bending that weakened and broke strands of the cable. Thus, in the aircraft accident investigated, the cables probably had been preweakened by wearing, bending and breaking of filaments; and during the impact the pilot's body probably exerted force on the restraint system sufficient to break the cables.

These observations were reported to others in the Federal Aviation Administration and published in General Aviation Inspection AIDS (3), a bulletin that calls technical matters to the attention of inspectors in the field. The manufacturer was also informed of the finding in this accident. Subsequent to the publication of this notice for inspectors, the manufacturer issued a service bulletin by which stronger and different cables were put in the aircraft and the configuration of the lead-in through the bulkhead was modified so as to eliminate most of the bending. Since the modification, there have been no accidents in which we have observed the cables to have broken and an examination of operational aircraft in the field has revealed no flaws in the cables.

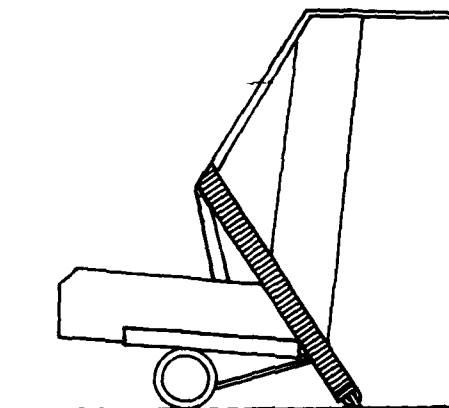
An additional crashworthiness feature involves an aircraft in which the main spar is a large aluminum tube that passes through the cockpit. This hollow tube serves also as a fuel cell. The two-seat aircraft has both seats mounted side by side on a small metallic track directly on top of the main spar. The bottom of the seat is plywood and the seat cushion consists of 2 inches of foam rubber. This arrangement appears to offer little attenuation of impact forces by the seat. During impact, forces, particularly vertical forces, would tend to be transmitted through the main spar to the pelvis and the axial spine of the occupant.

Figure XI. Schematic of aircraft seat showing mounting directly over large tubular main spar with little space or structure to attenuate vertical impact forces.
